Assessing the Influence of Anthropogenic Factors on Water Quality: A Case Study of Ikpa River Basin, Akwa Ibom State

Original Research Article

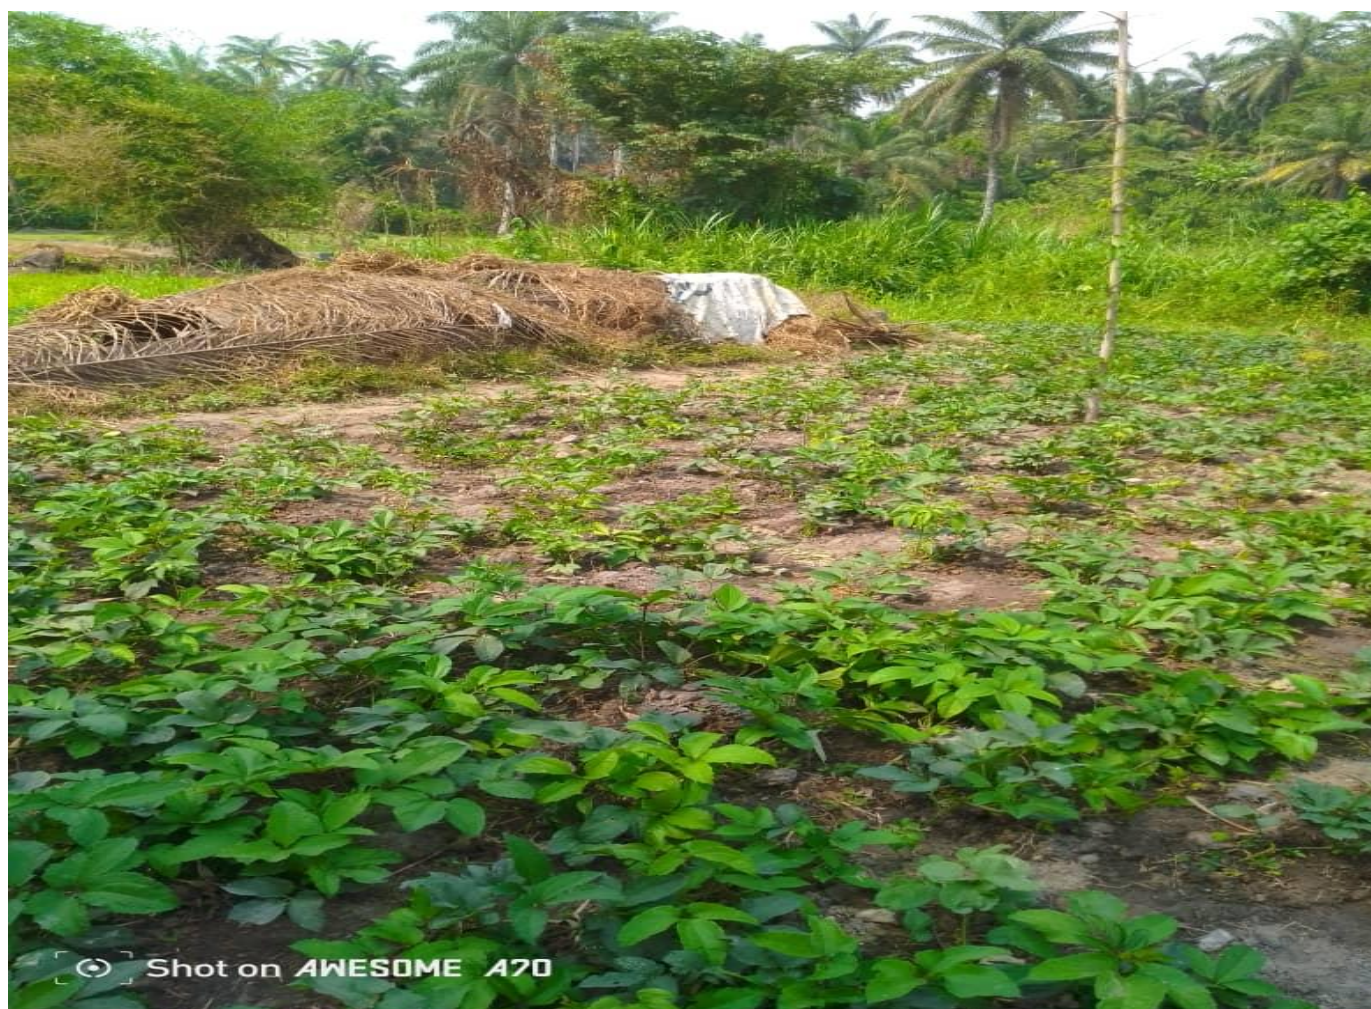
Farming which had 140 individuals representing 37.33% of the surveyed population, stands out as the most prevalent activity. This suggests significant agricultural practices within the basin, potentially impacting water quality through fertilizer and pesticide runoff, as well as land use changes leading to erosion and sedimentation.

Figure4.1: Farming activities in the river basin

Result of the study shows that within Ikpa River Basin the dominant anthropogenic activities within the basin are agriculture (farming), resource extraction (sand mining and quarrying), and industrial/commercial activities (mechanic workshops and palm oil processing). Each of these activities carries specific potential environmental impacts that need to be further investigated to understand their cumulative effect on the Ikpa River ecosystem. The most dominant anthropogenic activity within the Ikpa River basin, as indicated by the questionnaire data is agriculture (farming). Farming with 140 individuals representing 37.33% of the surveyed population, stands out as the most prevalent activity. This suggests significant agricultural practices within the basin, potentially impacting water quality through fertilizer and pesticide runoff, as well as land use changes leading to erosion and sedimentation.

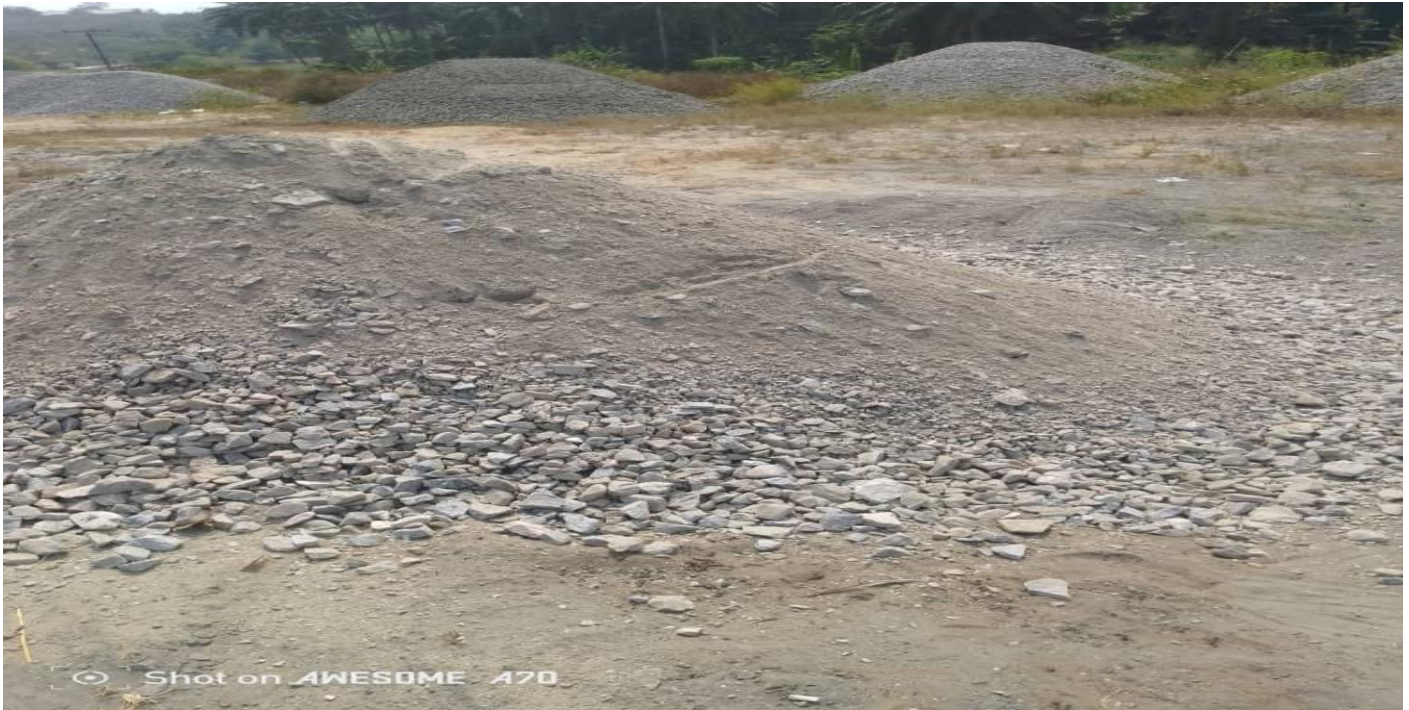
Quarrying: Following farming, had 62 respondents (16.53%). It also represents a significant extractive industry within the basin. Quarrying operations which involve the removal of large amounts of rock and soil, which can contribute to sedimentation, habitat loss, and potential contamination of water sources through dust and chemical runoff.

Figure 4.2 Quarrying activities in the study area

Following farming was quarrying, involving 62 respondents (16.53%), which also represents a significant extractive industry within the basin. Quarrying operations often involve the removal of large amounts of rock and soil, which can contribute to sedimentation, habitat loss, and potential contamination of water sources through dust and chemical runoff. Sand mining engaged 61 respondents (16.27%) indicates substantial extraction of sand resources from the river or its surroundings. This activity can lead to riverbed degradation, altered flow patterns, increased turbidity, and habitat destruction, directly affecting the aquatic ecosystem.

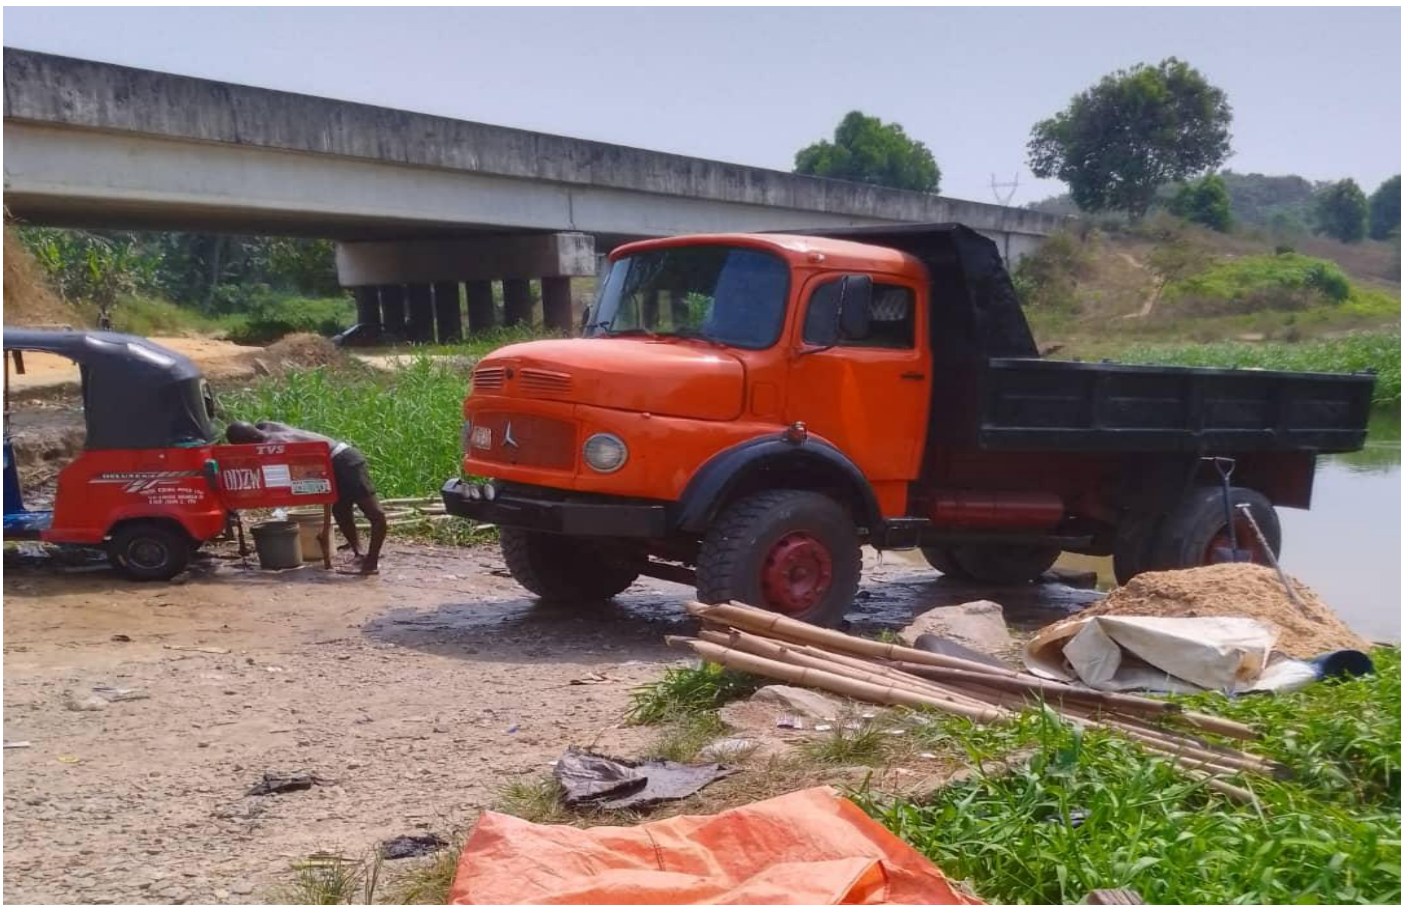
Sand mining: This involved 61 respondents (16.27%), indicating substantial extraction of sand resources from the river or its surroundings. This activity can lead to riverbed degradation, altered flow patterns, increased turbidity, and habitat destruction directly affecting the aquatic ecosystem.

Figure 4.3: Sand mining activities in the study area

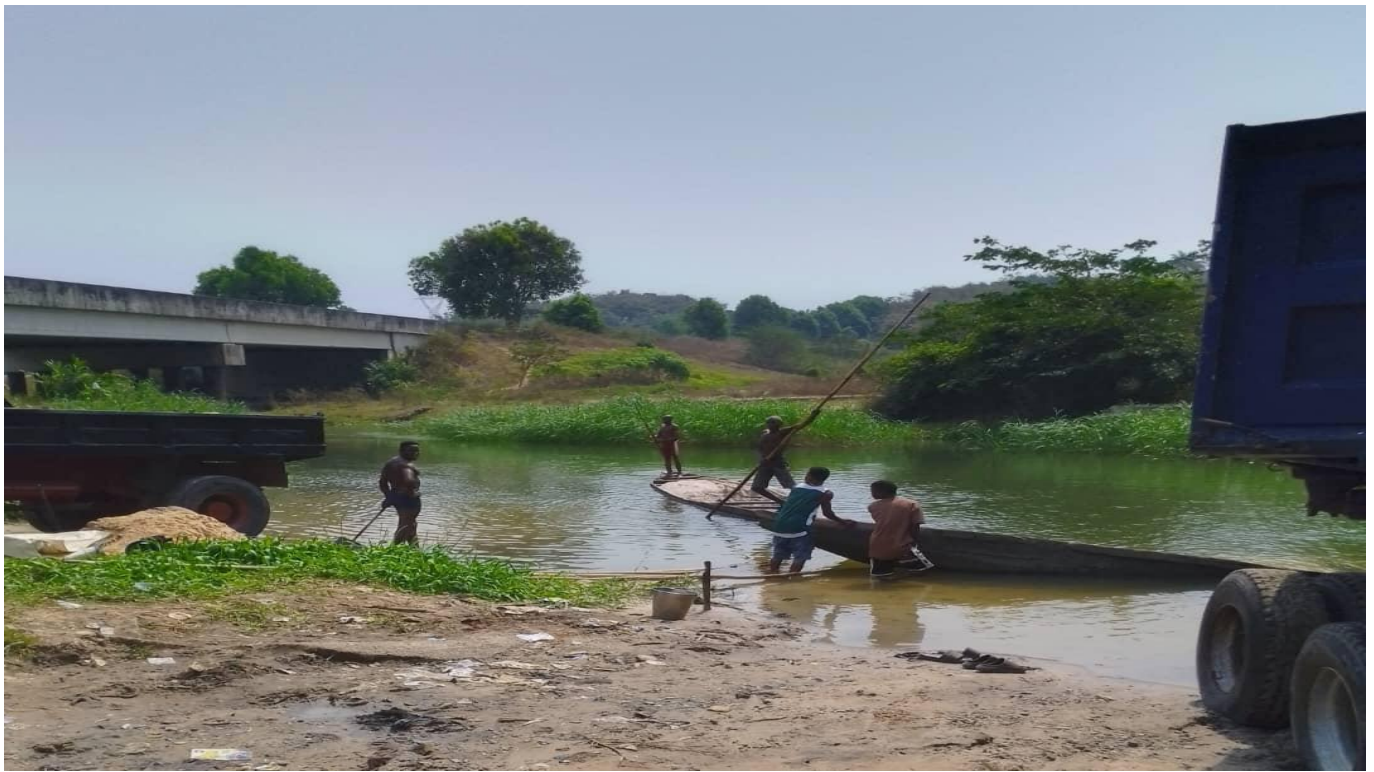
Figure 4.4: Sand mining activities in the study area

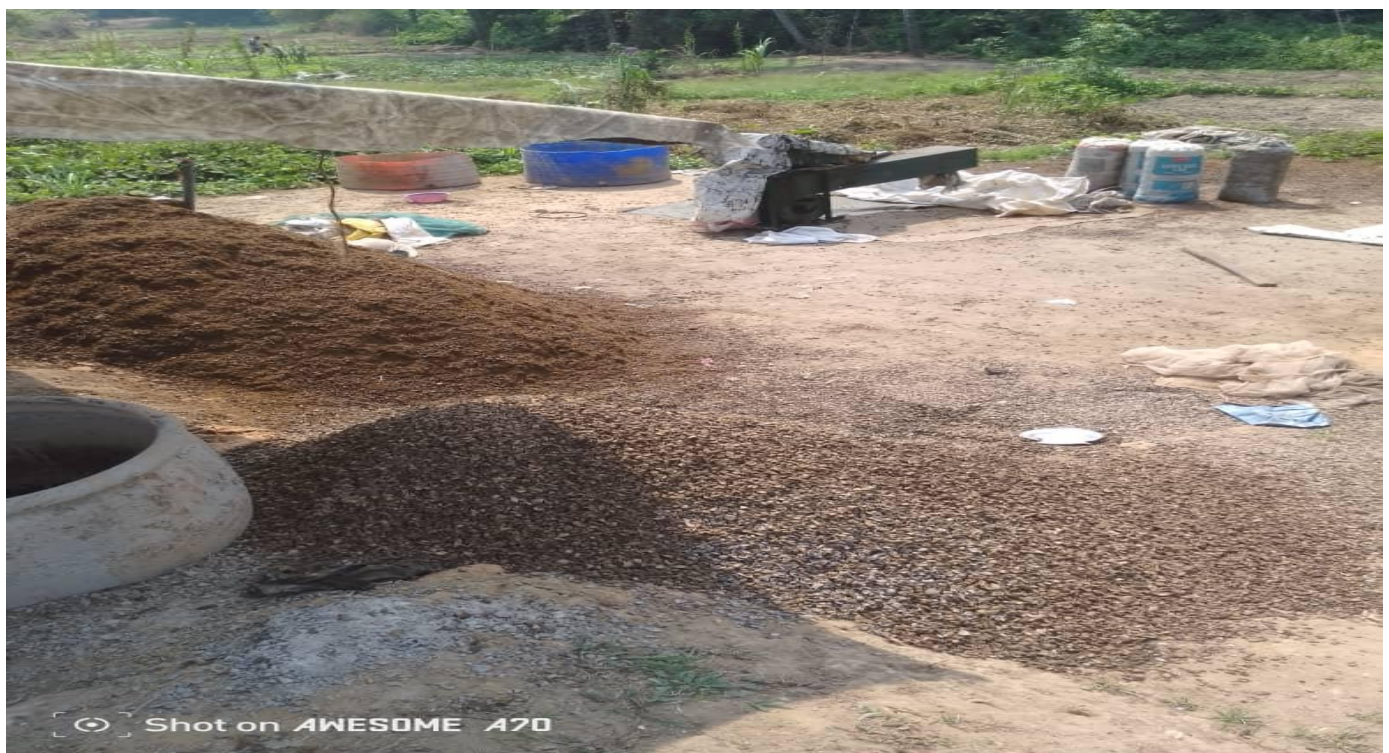
Palm oil processing, involving 57 respondents (15.2%), indicates agro-industrial activity within the area. Palm oil processing can generate significant wastewater containing organic matter and nutrients, which, if not properly managed, can lead to water pollution and oxygen depletion in the Ikpa River.

Figure 4.5: Palm oil proceeds (palm kernel shells)

Next was Palm oil processing, involving 57 respondents (15.20%), indicates agro-industrial activity within the area. Palm oil processing can generate significant wastewater containing organic matter and nutrients, which, if not properly managed, can lead to water pollution and oxygen depletion in the Ikpa River. Finally, Mechanic workshops, with 55 respondents (14.67%), suggest the presence of automotive repair and maintenance activities. These can introduce pollutants like oil, grease, heavy metals, and solvents into the environment, potentially contaminating surface and groundwater within the river basin.
